# PGM-FI Control System

## Troubleshooting Flow Chart — CYL Sensor

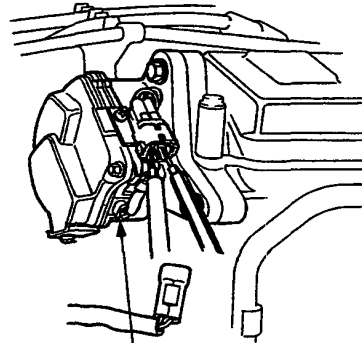
CYL SENSOR

Disconnect the 2P connector from the CYL sensor.

Measure resistance between 2 terminals on the CYL sensor.

Is there 700—1,000  $\Omega$ ?

Check for continuity to body ground on the 2 terminals individually.
